# Neutralization of Acidic Discharges From Abandoned Underground Coal Mines by Alkaline Injection

By William W. Aljoe and Jay W. Hawkins

**Report of Investigations 9468**

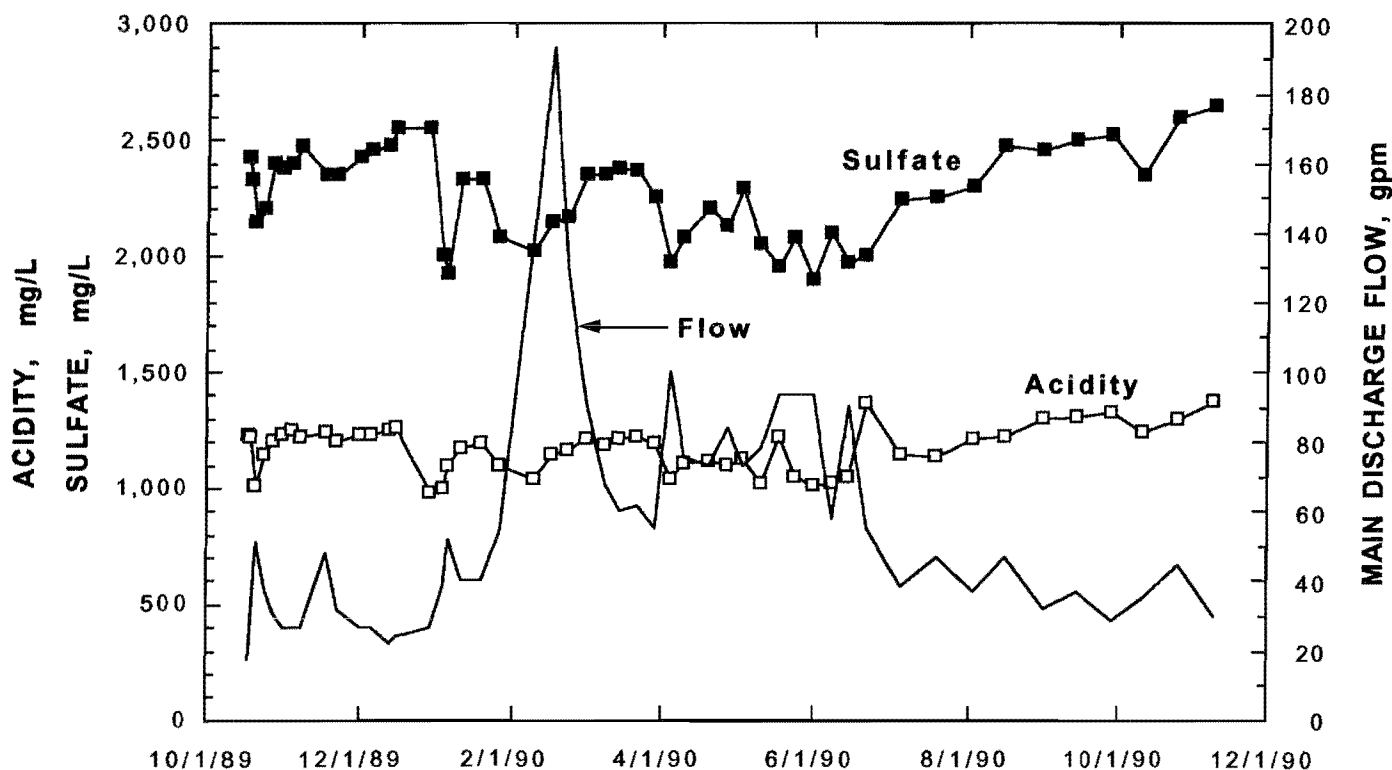
Figure 29.—Acidity and sulfate concentrations at main discharge, Friendship Hill site.

Note also in figure 29 that contaminant concentrations increased steadily during July through November 1990, and that the correspondence between contaminant concentration decreases and flow increases was less pronounced. Despite the reduced infiltration during this time period, the unsaturated caved zone and fractures immediately above the mine pool still would contain enough moisture to sustain pyrite oxidation and acid salt formation. When pool recharge became sufficient to produce a flow increase, the effects of dilution may have been offset by increased salt flushing by infiltrating waters. The increasing contaminant concentrations and decreasing flows shown in figure 29 may represent the net result of the lower frequency and magnitude of flushing events during the summer and fall.

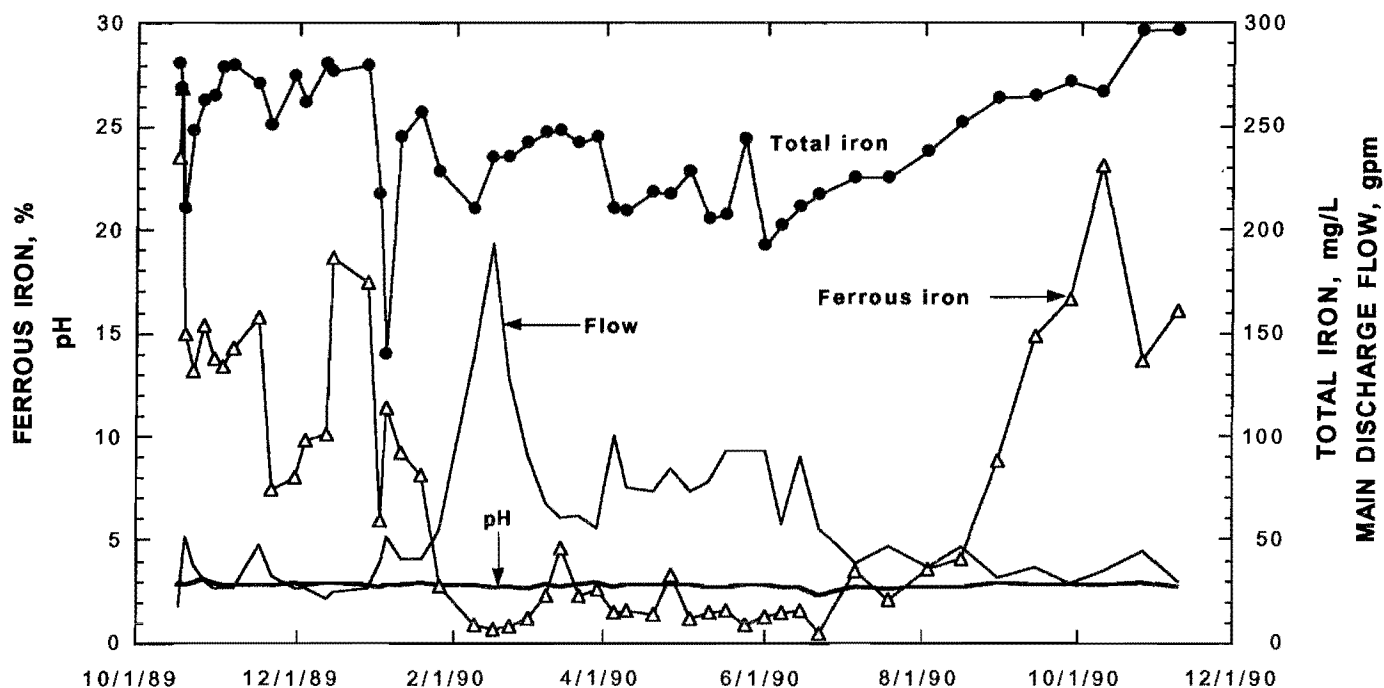
Figure 30.—Iron concentrations, ferrous percentages, and pH at main discharge, Friendship Hill site.

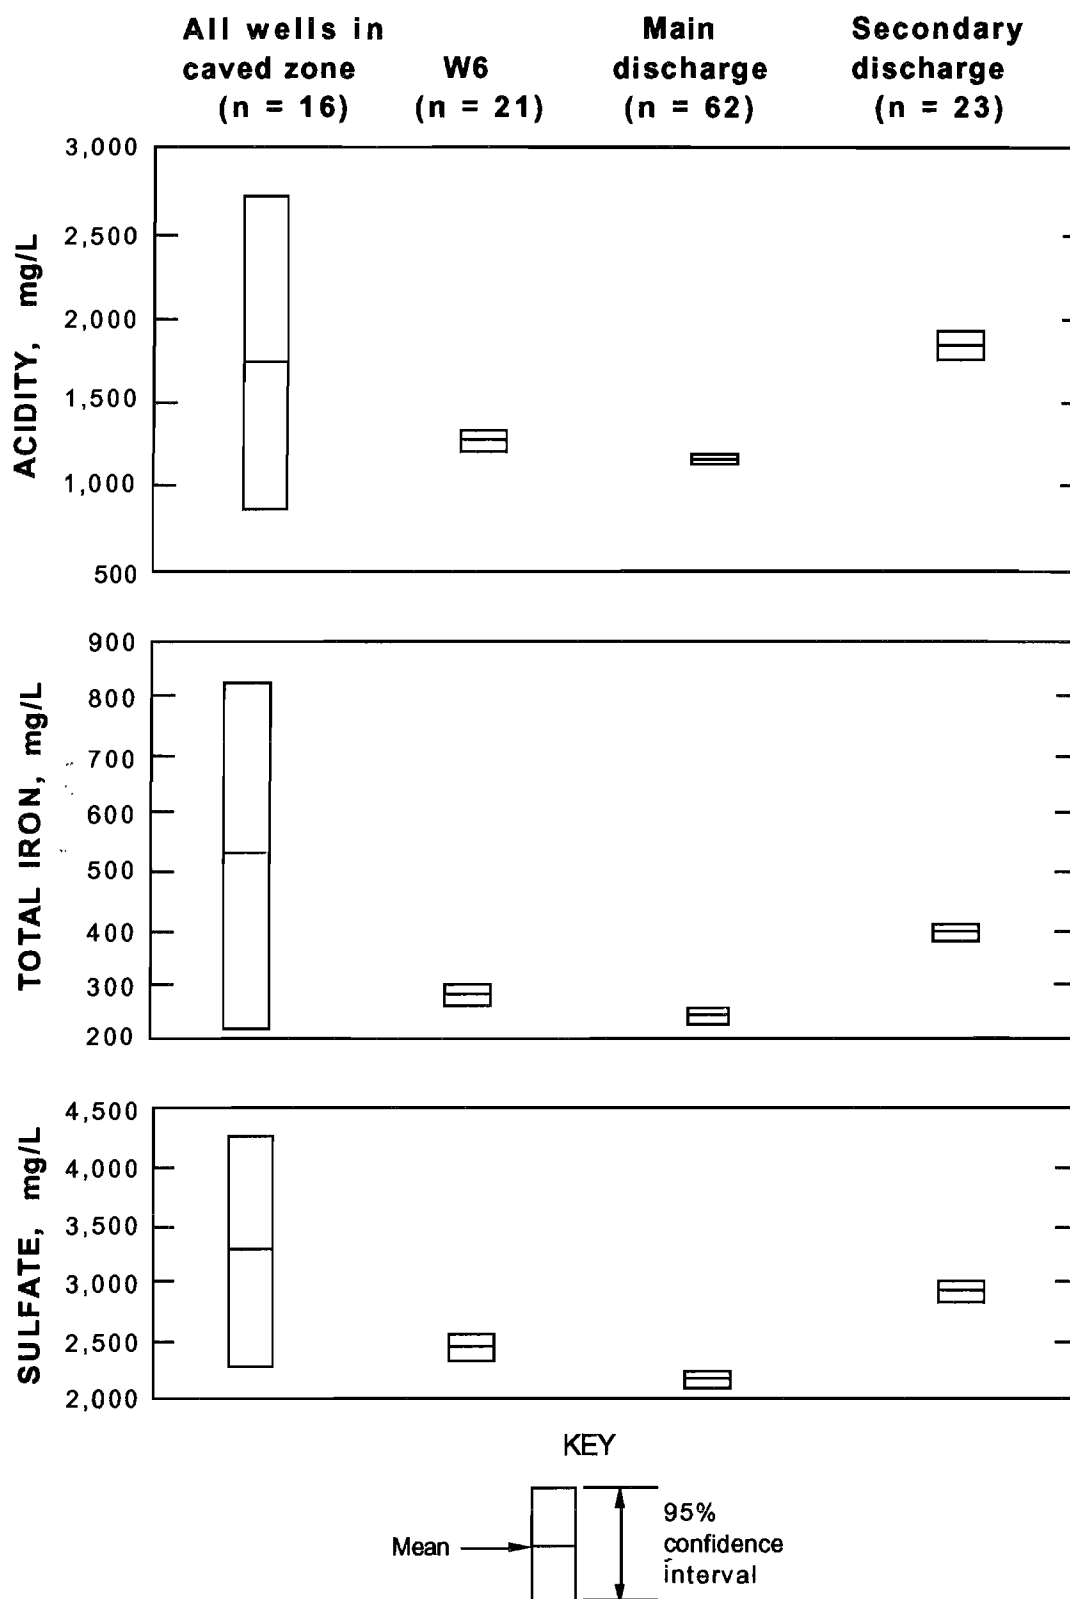
Figure 31.—Average water quality in monitoring wells and mine discharges, Friendship Hill site.

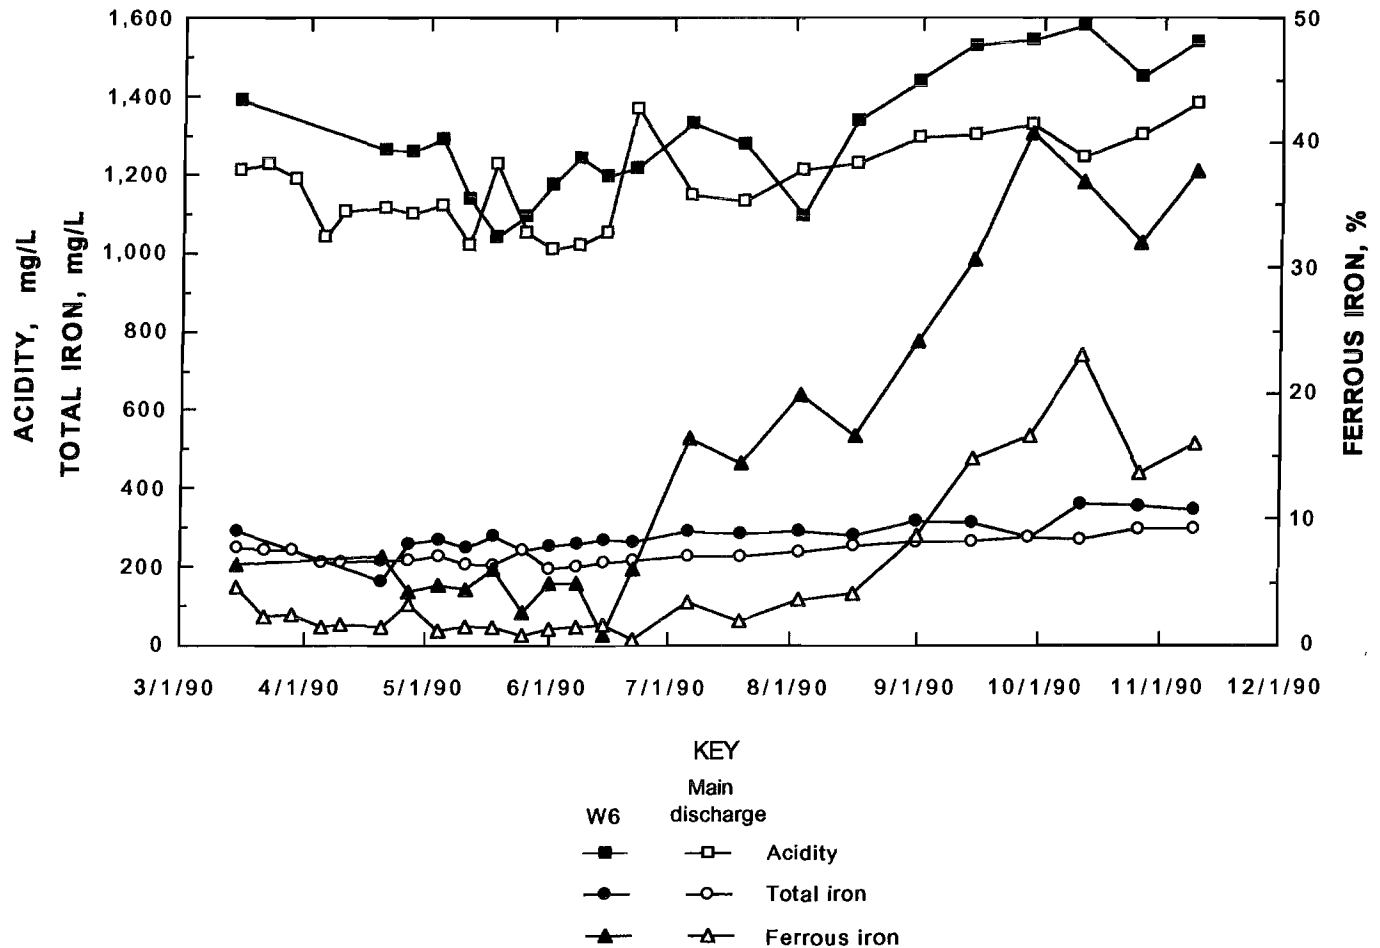
Figure 32.—Comparison of water quality parameters in well 6 and main discharge, Friendship Hill site.

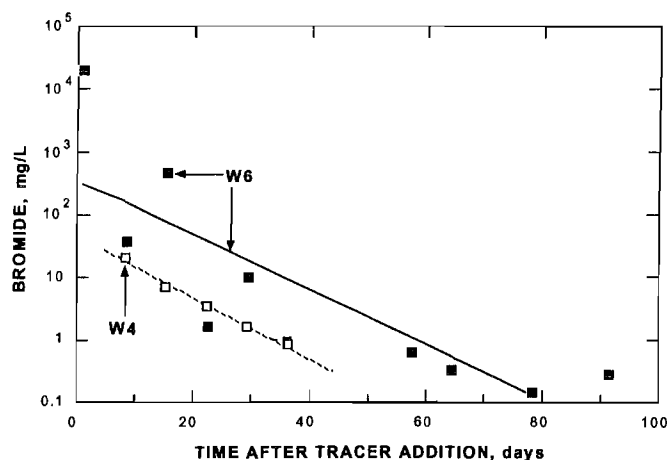
Figure 33.—Decline of bromide concentrations at tracer injection well (W6) and monitoring well (W4), Friendship Hill site.

concentration in well 4 after initial detection suggested that the peak tracer concentration in well 4 occurred before the first sample was taken, and that the mean travel time between wells 6 and 4 was less than 1 week. The exponential decline of bromide concentration shown in figure 33 suggests that flow-related dilution was occurring at the wells. Since the distance from well 6 to well 4 was approximately 100 ft, the flow velocity would have been more than 14 ft/d. This was considerably higher than expected, especially since well 4 responded in a steady, predictable manner in the slug tests, with a hydraulic conductivity of  $3.9 \times 10^{-4}$  ft/min. However, since a slug test influences only a very small aquifer volume, there may have been a conduit in the vicinity of wells 6 and 4 that was not detected in the slug tests but still allowed a rapid migration of tracer between the two wells. Note on the mine map (figs. 25-26) that a partially open mine entry may have connected wells 6 and 4.

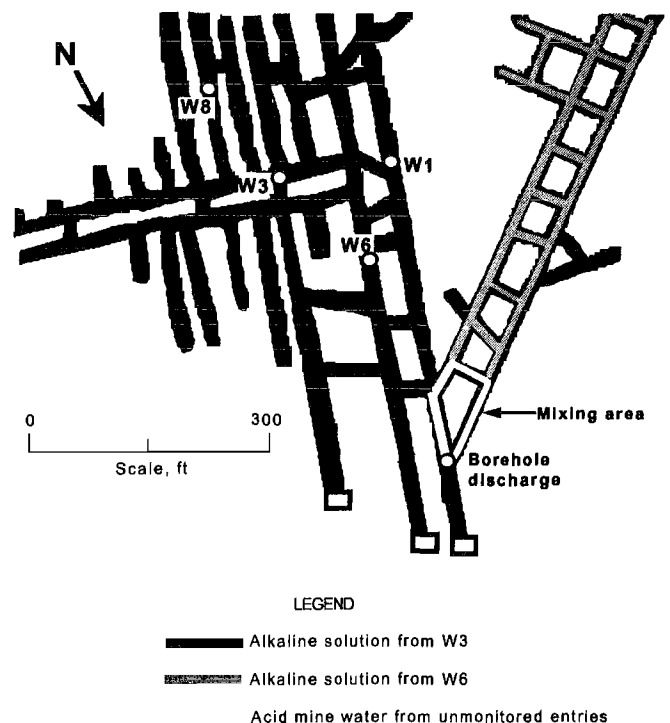
Figure 34.—Potential flow paths of injected alkaline solution, Keystone site.

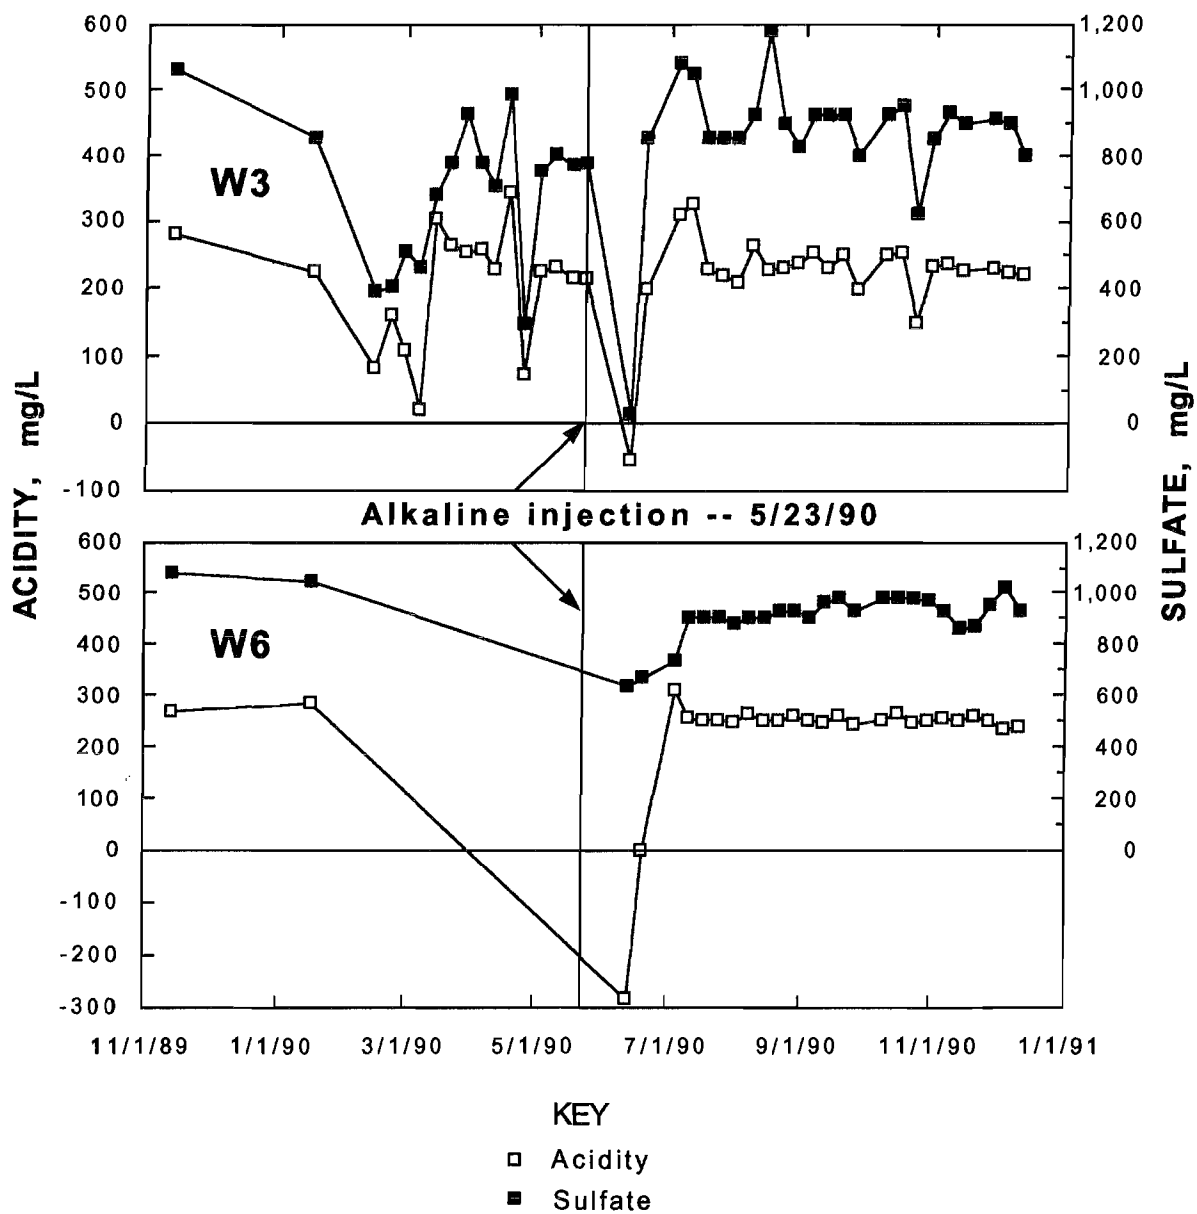
Figure 35.—Sulfate and acidity concentrations in alkaline injection wells (W3 and W6), Keystone site.

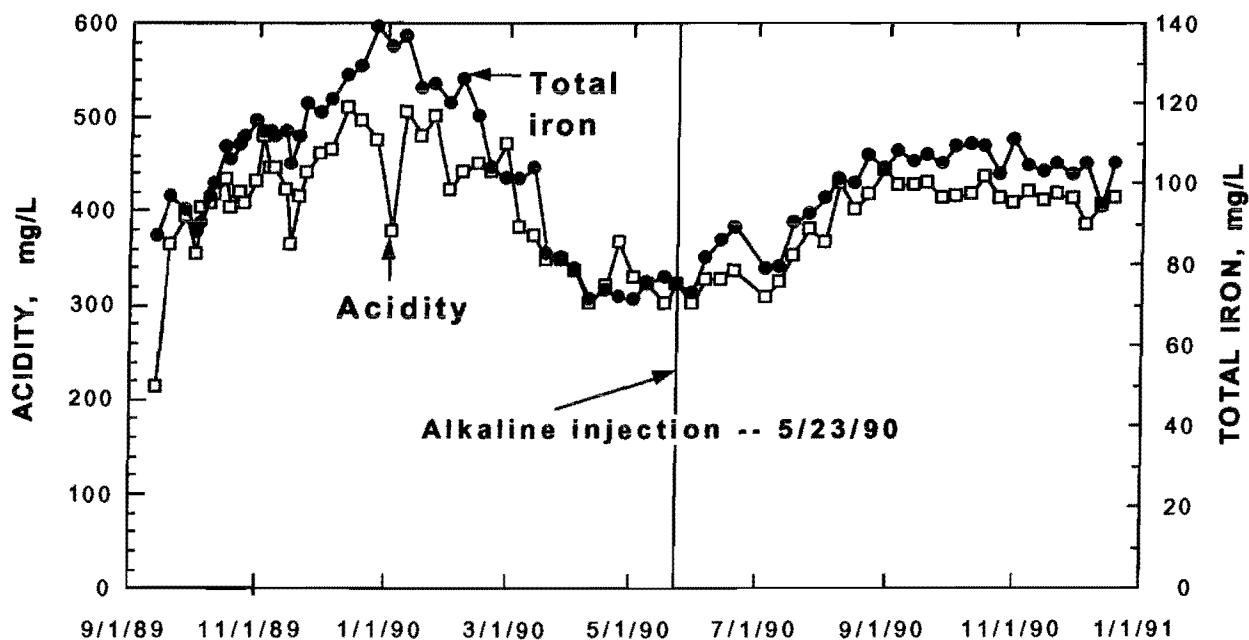
Figure 36.—Acidity and total iron concentrations at mine discharge, Keystone site, before and after alkaline injection.

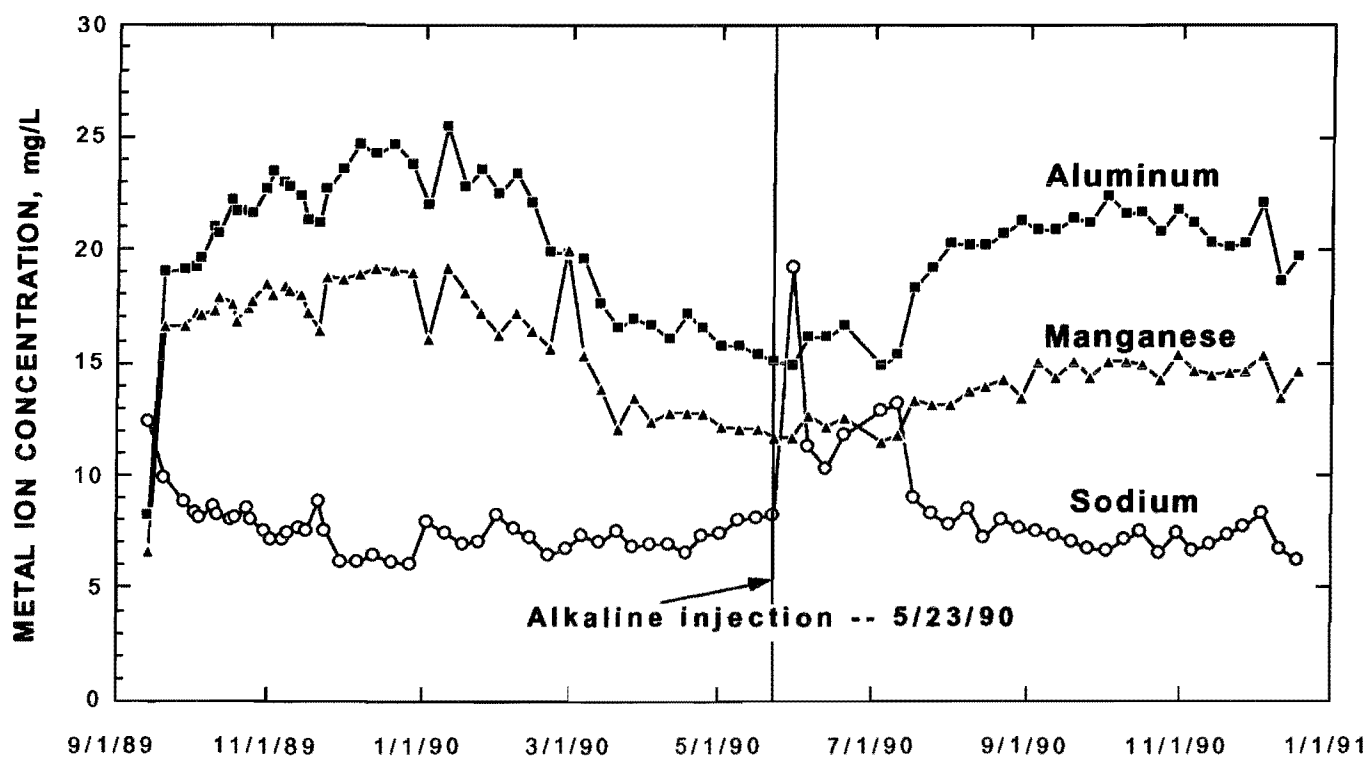
Figure 37.—Aluminum, manganese, and sodium concentrations at mine discharge, Keystone site, before and after alkaline injection.

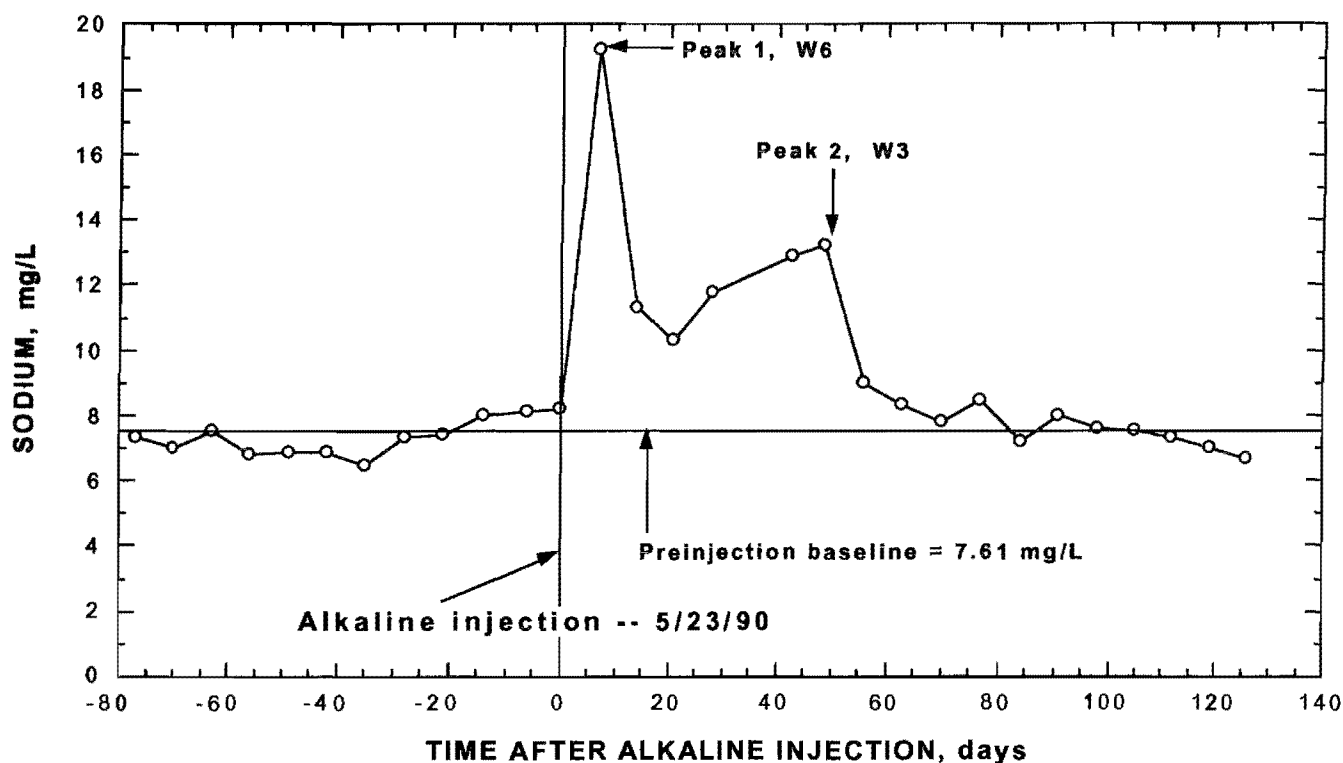
Figure 38.—Arrival of injected sodium at mine discharge, Keystone site.

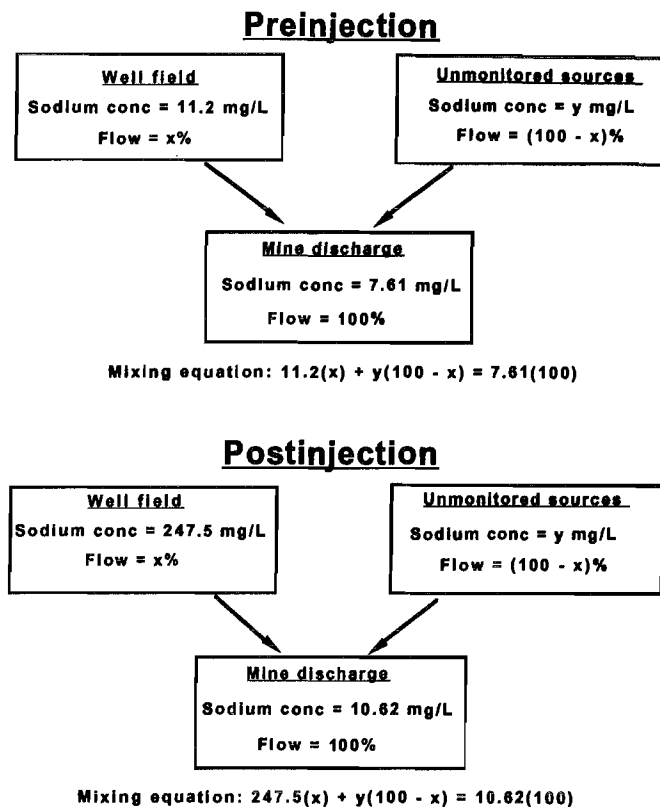
Figure 39.—Diagram of hypothetical sodium mixing process, Keystone site.

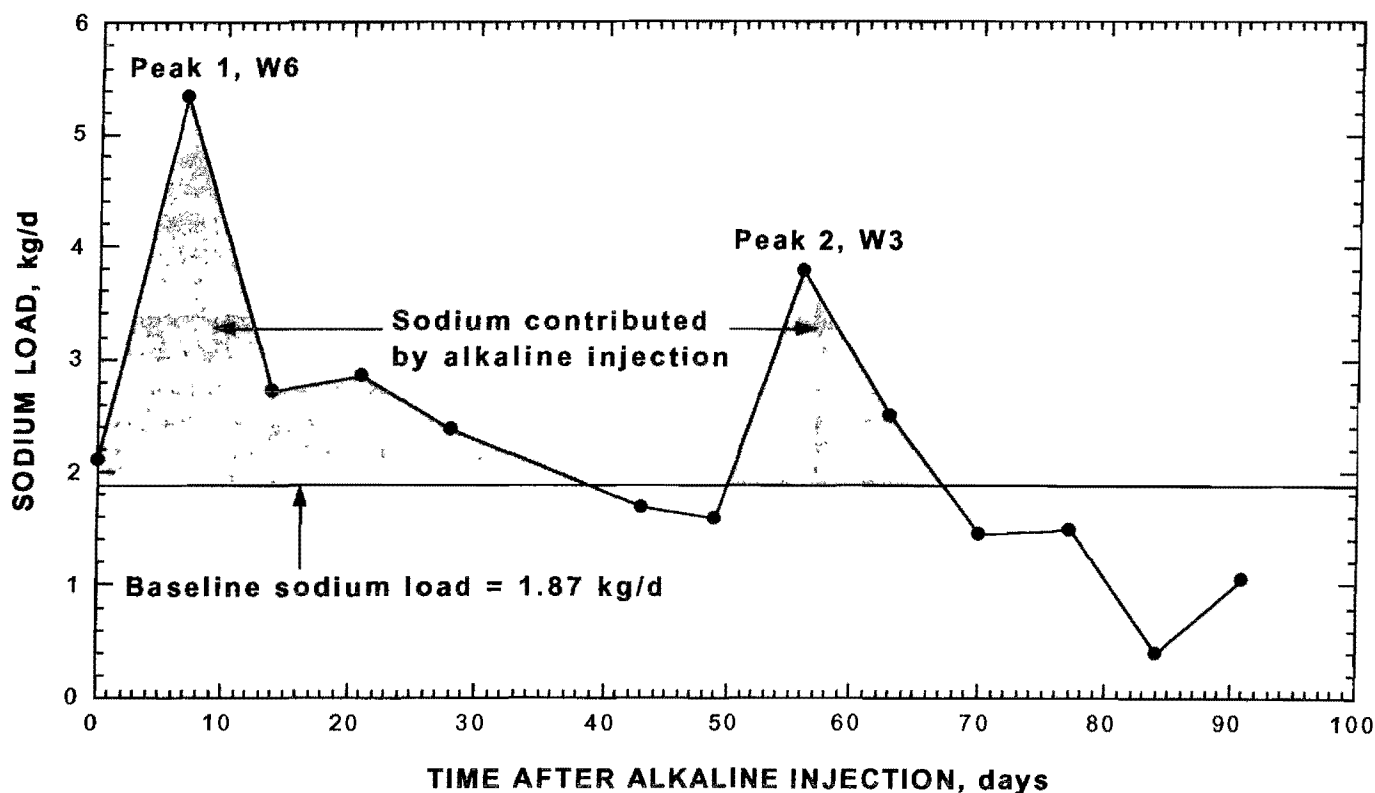
Figure 40.—Sodium loading at mine discharge after alkaline injection, Keystone site.

The total amount of sodium leaving the mine during the 3 months after alkaline injection was found to be about 204 kg by computing the entire area under the plot in figure 40. However, since the average preinjection (baseline) sodium loading was 1.87 kg/d, an estimate of the contribution of alkaline injection to the total loading can be made by computing the shaded area in figure 40. This estimate (58.3 kg) was only about 5.4% of the total injected sodium mass (1,087 kg); the remaining 94.6% of the injected
